CALSPAN ON-SITE VEHICLE DEFECT INVESTIGATION

CALSPAN CASE NO. 92-5

VEHICLE - 1992 FORD AEROSTAR XL MINIVAN

14. Sponsoring Agency Code	
15. Supplementary Notes On-site investigation of an alleged vehicle defect that involved a 1992 Ford Aerostar minivan. The upper rear control arm separated from its mount which resulted in lateral instability and subsequent rollover of the vehicle.

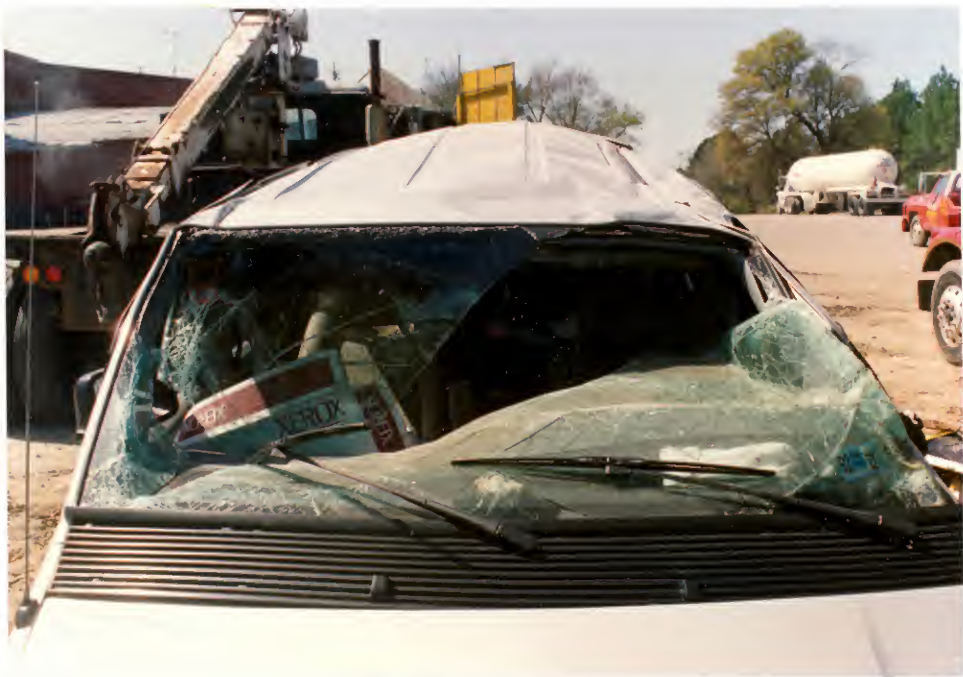
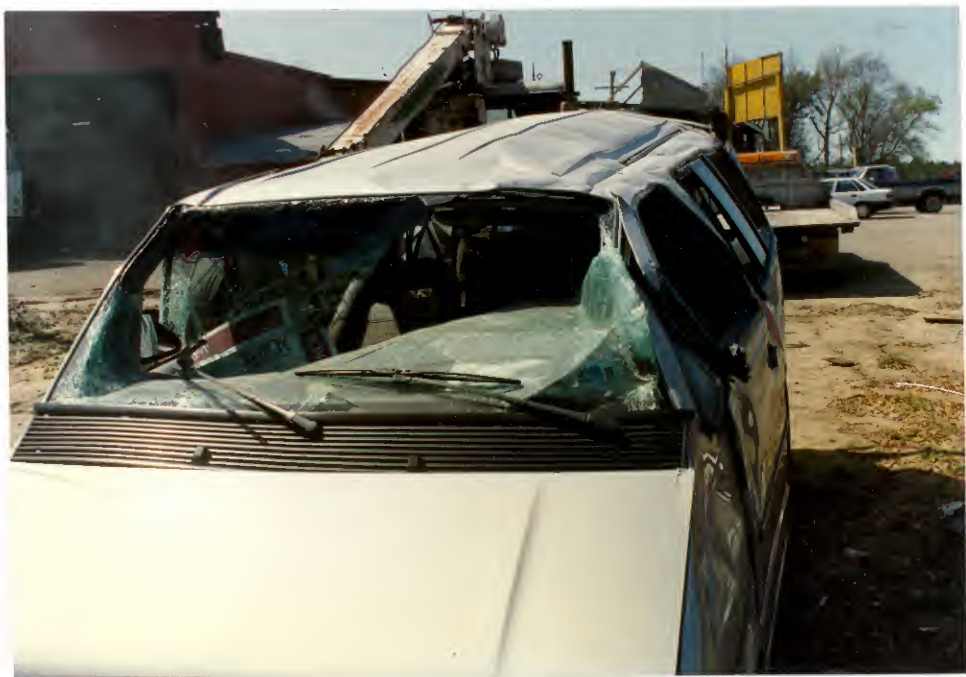
Roof Deformations.

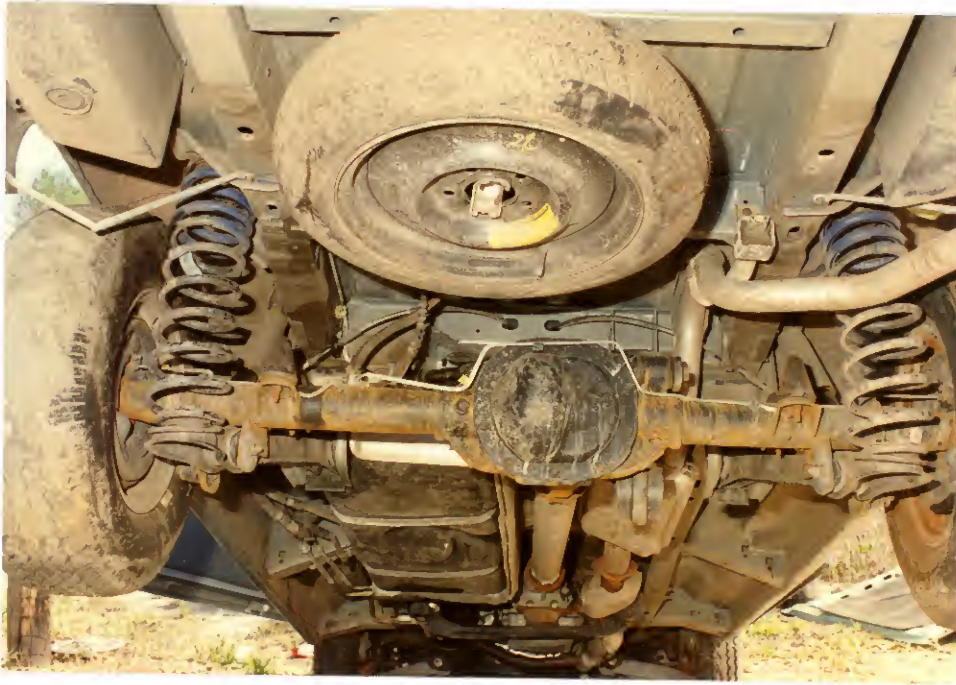
Rear Undercarriage View Of The Ford Aerostar.

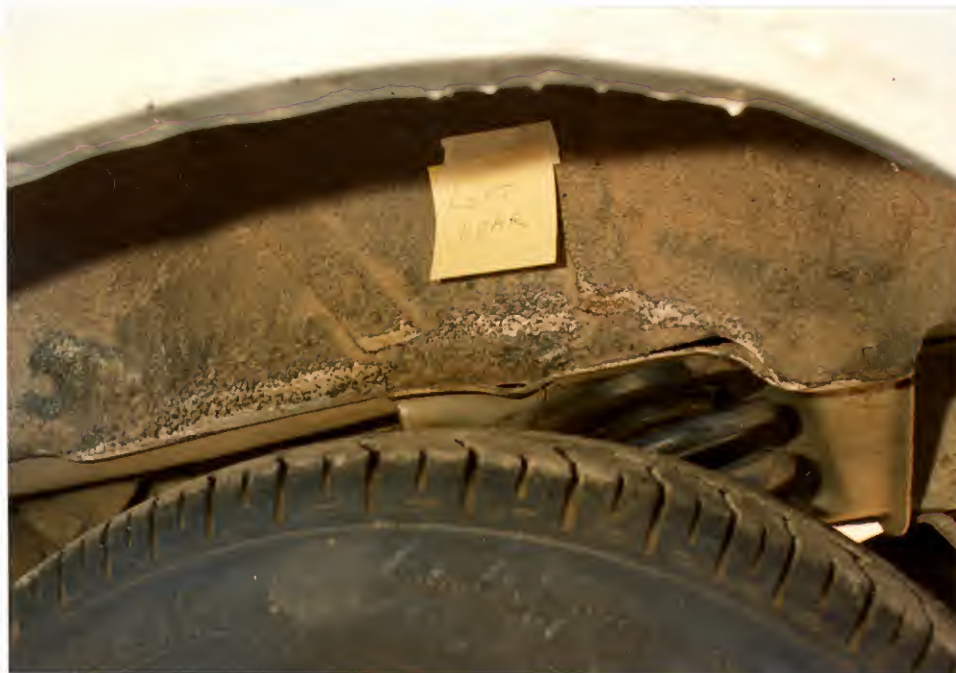
The roll pin fractured which allowed the stud to separate from the control arm and fall from the vehicle. As a result, the rear axle was free to move laterally, thus producing lateral instability in the vehicle. The rear tires subsequently contacted the inner aspects of the wheel openings, which abraded the undercoating from the sheetmetal and deformed the inboard edges of the inner wheel openings. The tires also contacted the rear coil springs which were jacketed by vinyl (top 4 coils). The left rear tire scuffed the left coil spring jacket while the right rear tire

Tire Abrasions To The Inner Wall Of The Left Rear Wheel Housing.

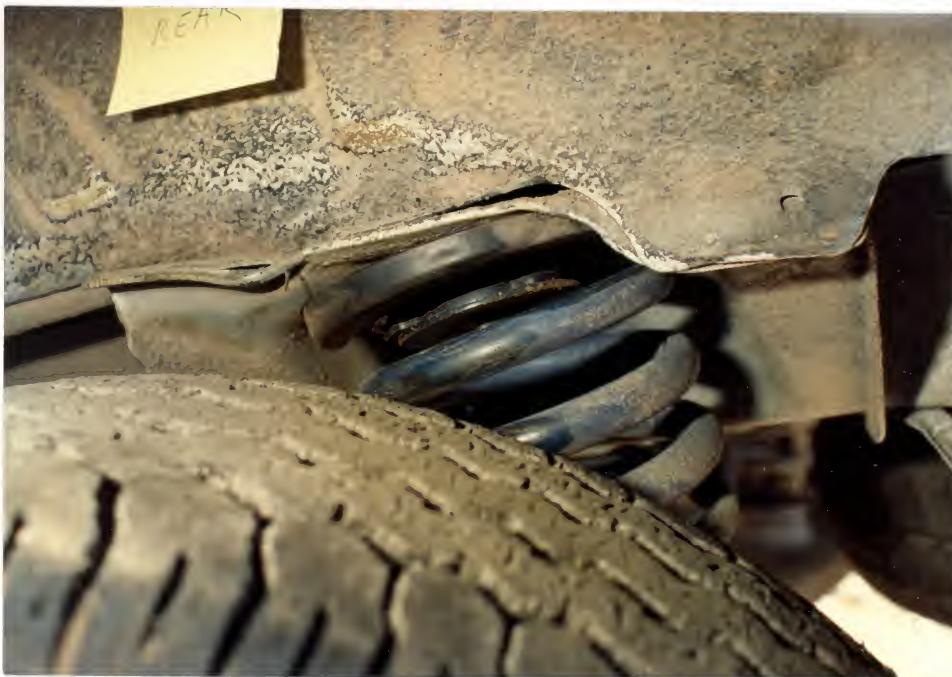
Tire Abrasions To The Vinyl Jacket On The Left Rear Coil Spring.

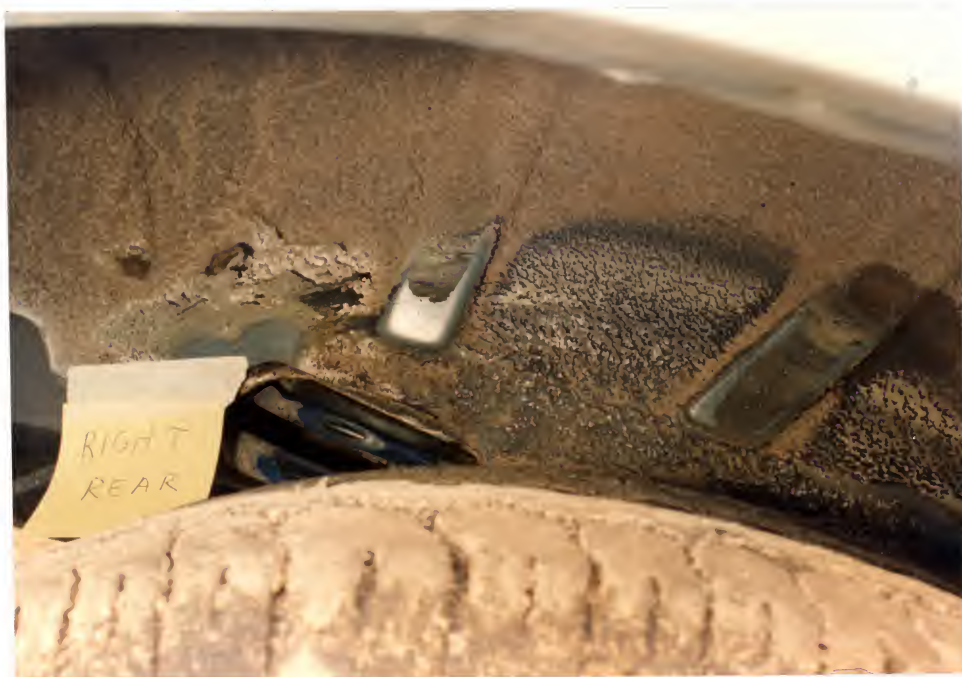
Tire Abrasions To The Right Rear Inner Wheel Housing.

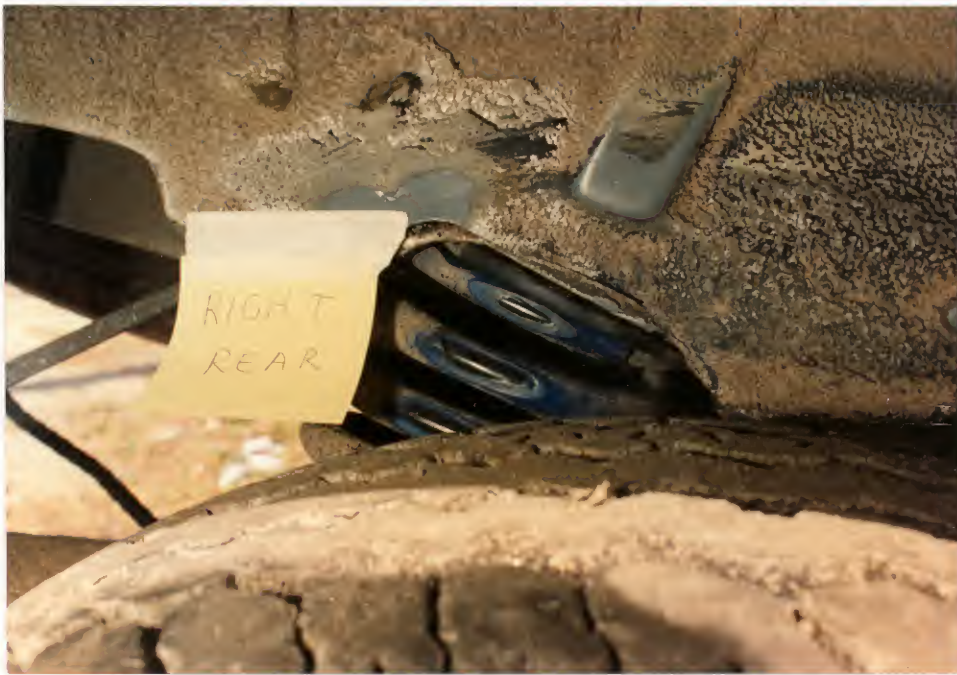
rubbed through the right vinyl spring covering. The abrasions to the coil spring coverings occurred as the wheels were rotating and the axle was shifting from side-to-side. The stud end of the upper control arm impacted the frame mounting bracket numerous times during the axle shift which produced circular gouges to the bracket.

Tire Abraded Jacket Of The Right Rear Coil Spring.

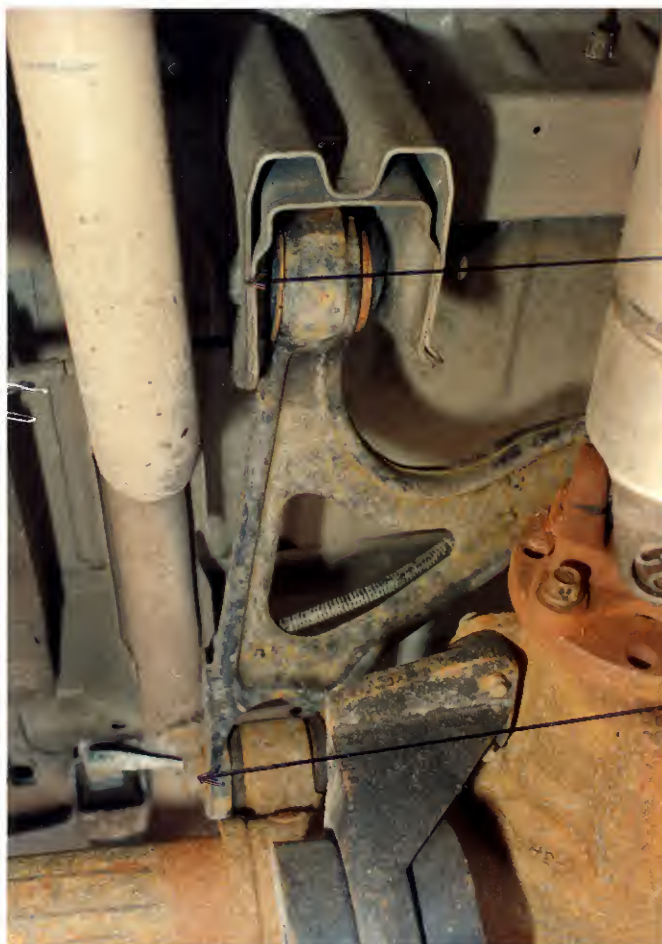
The rear bolt on the control arm required 150 ft. lbs. of torque to loosen the nut while the front mounted bolt and nut assembly required approximately 140 ft. lbs. of torque to loosen the nut. Torques were obtained from a one-half inch drive MAC tools torque wrench with a model number of [REDACTED].

Forward Bolt
Torqued At 140 Ft.Lbs.

Rear Axle Mounted Bolt
Torqued At 150 Ft.Lbs.

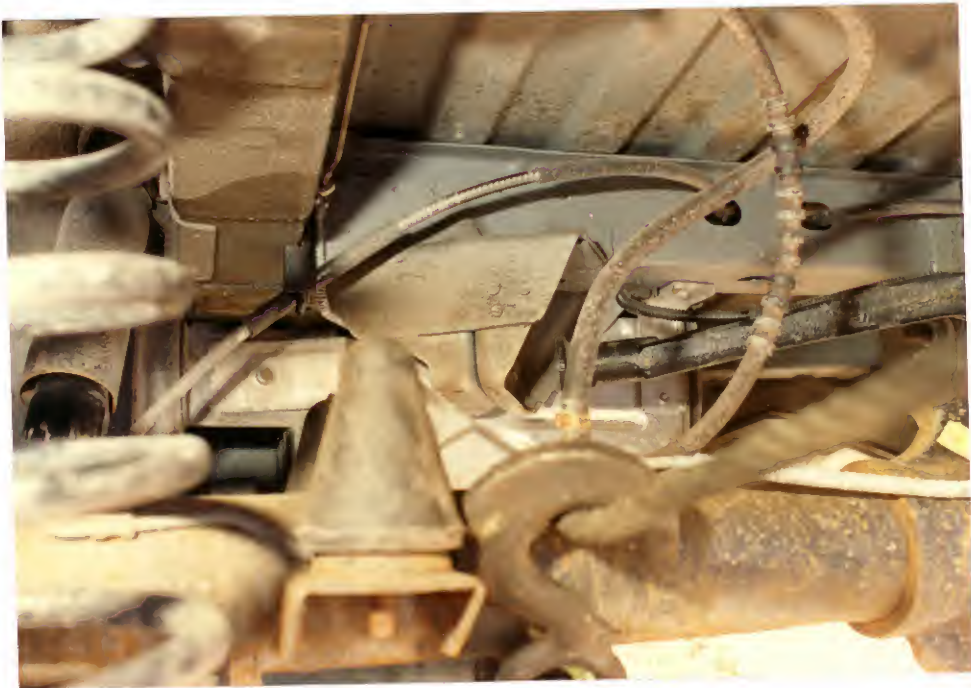
Separated Lateral Mount Of The Upper Control Arm.

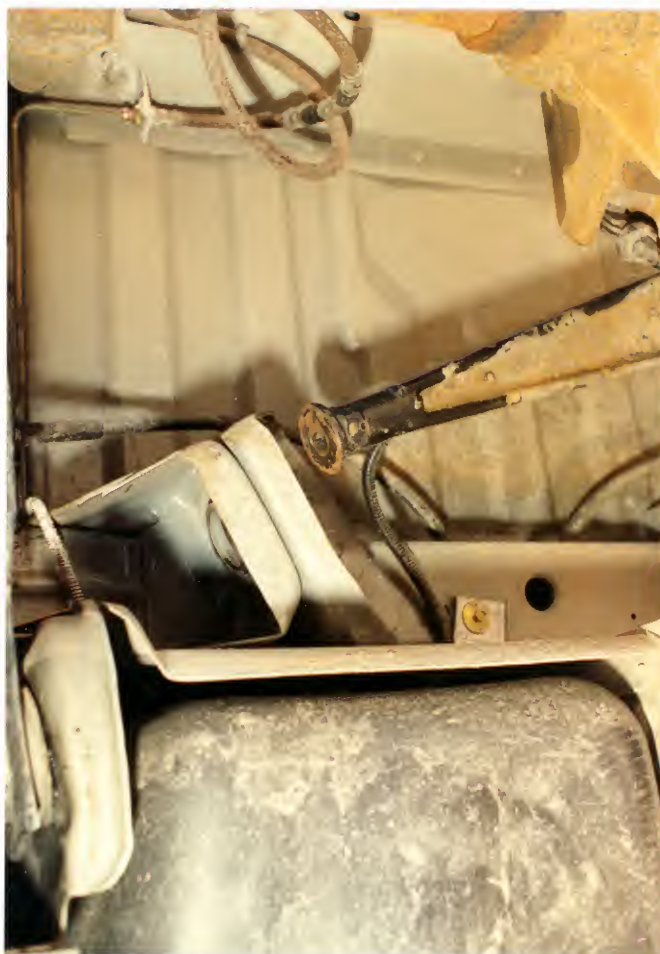
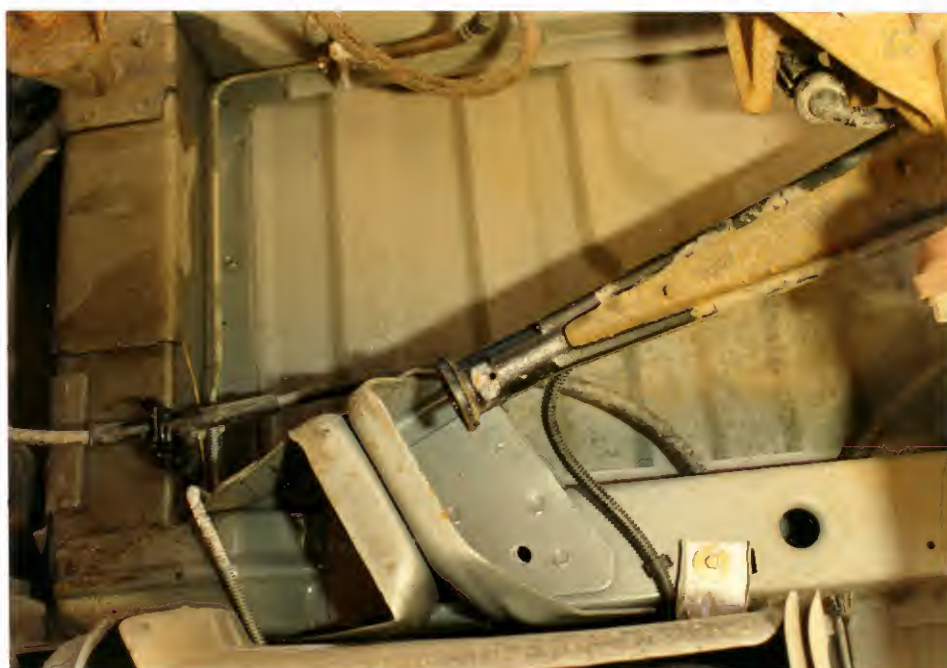
Separated Lateral Mounting Point Of The Rear Upper Control Arm.

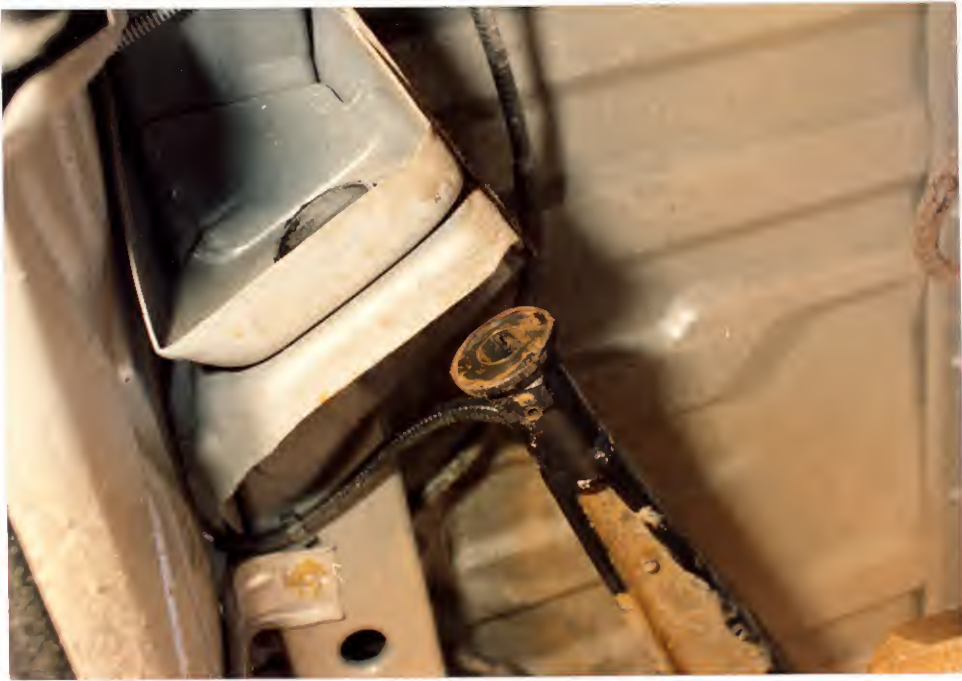
Closeup View Of The Stud Bore And Fractured 3/16" Diameter Roll Pin.

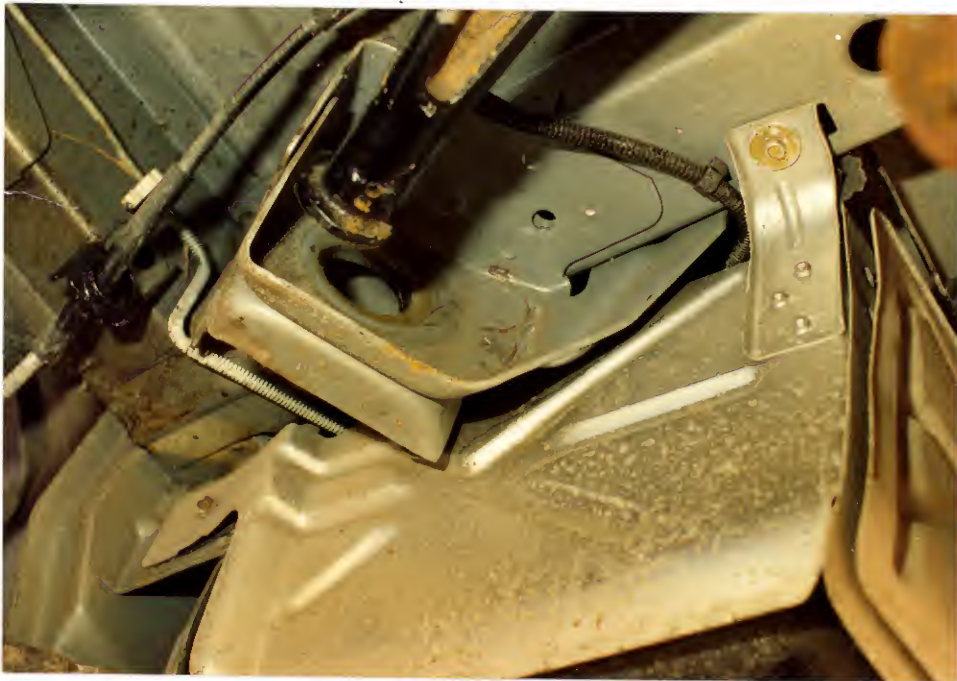
Control Arm Gouged The Lateral Mounting Bracket.

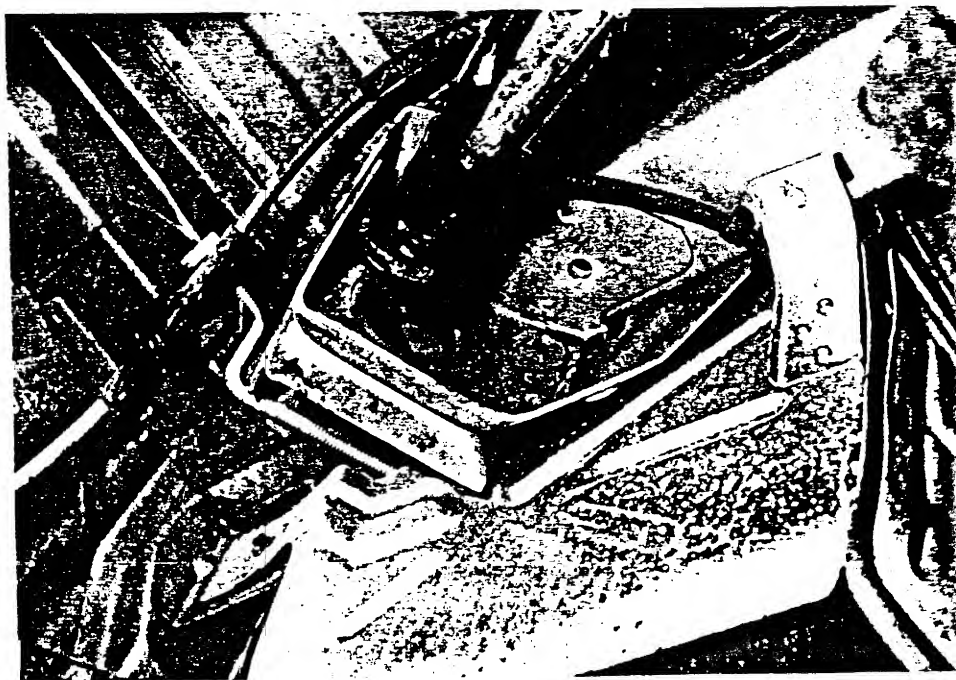
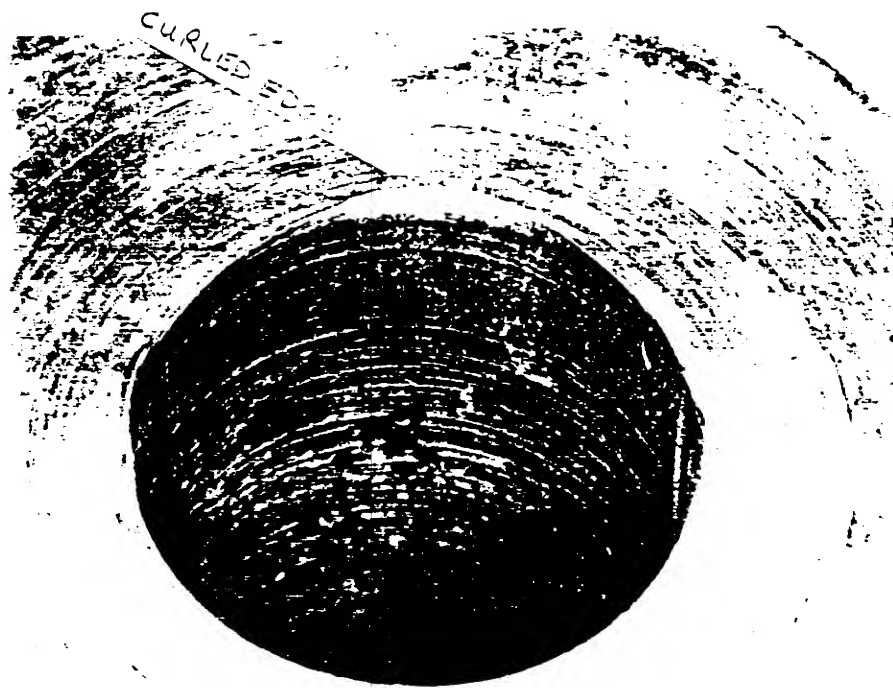
As shown in Figure 4, the right edge of the stud hole was curled, with no corresponding damage to the left edge of the hole. In addition, there were two severe gouges initiating from the two points where the roll pin transects the "stud hole" and proceeding in a linear manner (as opposed to a spiral) to the outer edge of the stud hole (Figure 5). Both of these gouges are visible to the naked eye and marked in Figure 6. Based upon this evidence, it is unlikely that the stud gradually worked its way out of the hole, but rather suddenly exited the hole.

FIGURE 4: Machined end of the
control arm (location C)

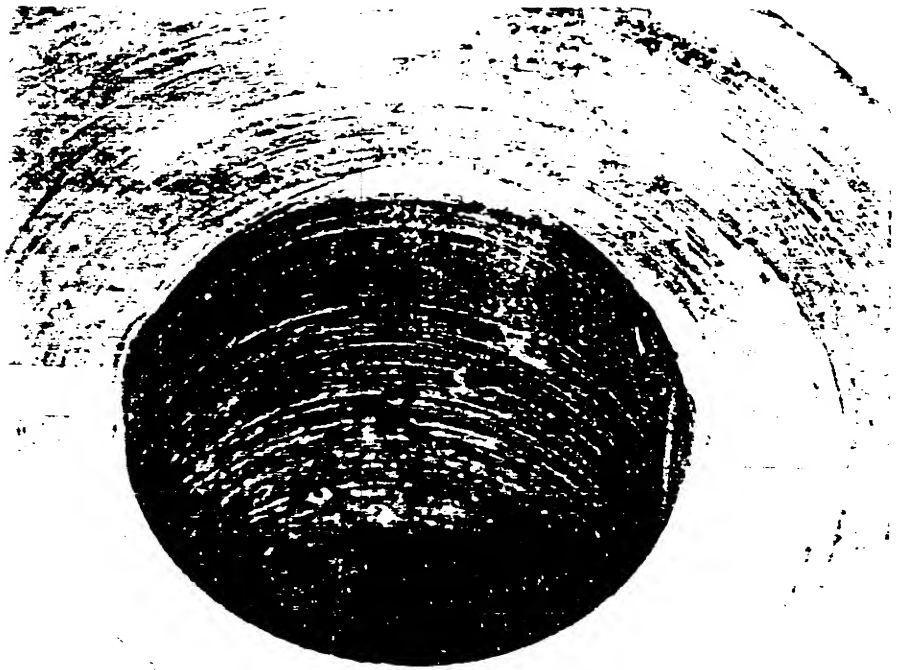
FIGURE 6: End of control arm with
corresponding gouging

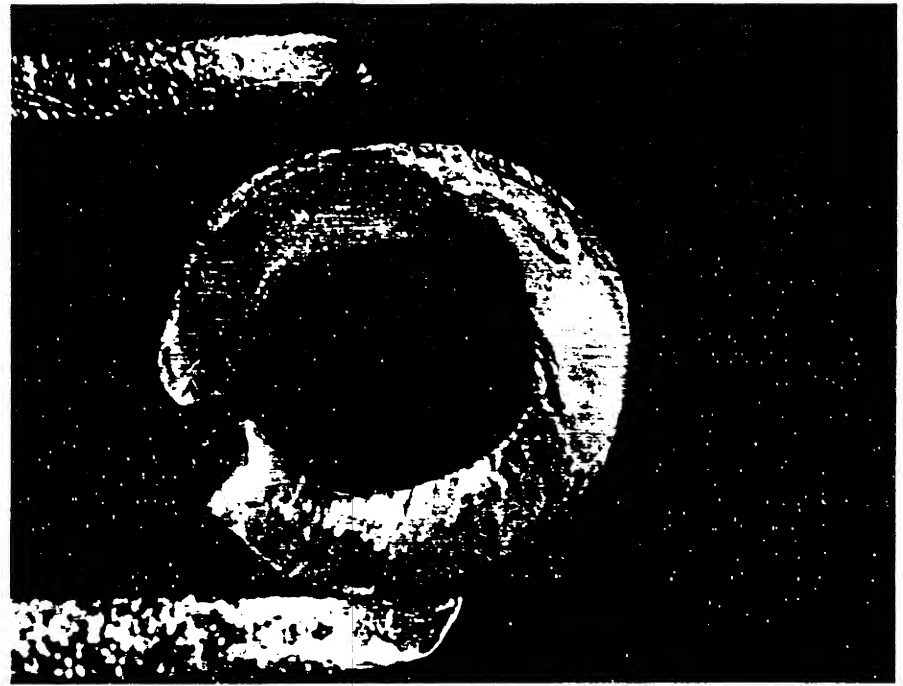
Top PIN

The top and bottom roll pin pieces were removed and examined (Figures 8 and 9), and the original findings of ductile overstress confirmed. The small amount of oxidation visible on the bottom roll pin piece did not appear to be the result of long term exposure. In addition, the irregular planes on the surface of both fractured roll pin pieces are indicative of secondary bending stresses. Such bending stresses would be expected considering the lack of evidence of an interference-type fit between the stud and hole.

FIGURE 8: Top roll pin piece

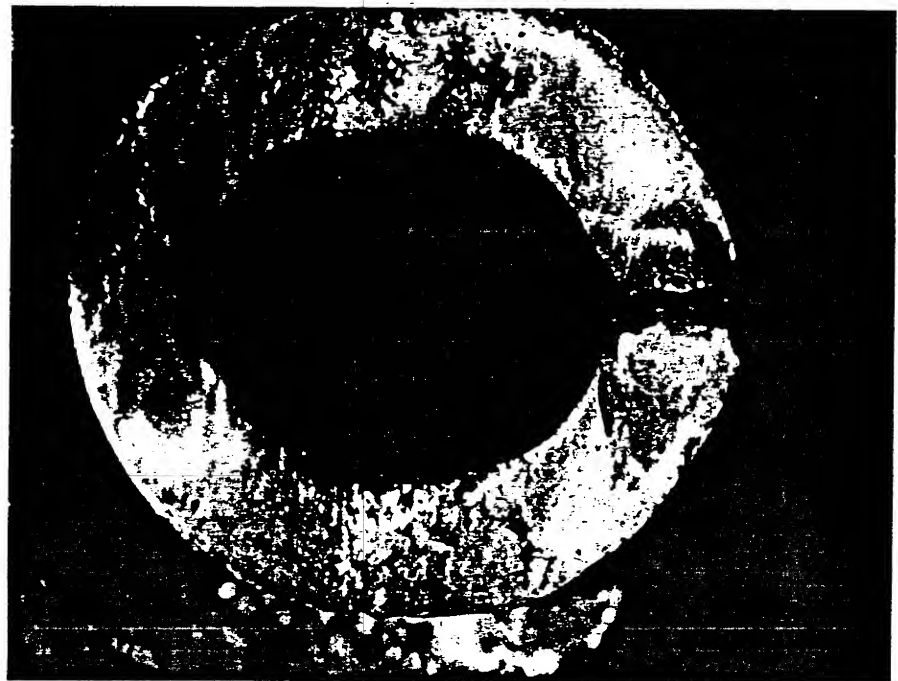
Bottom PIN

FIGURE 9: Bottom roll pin piece

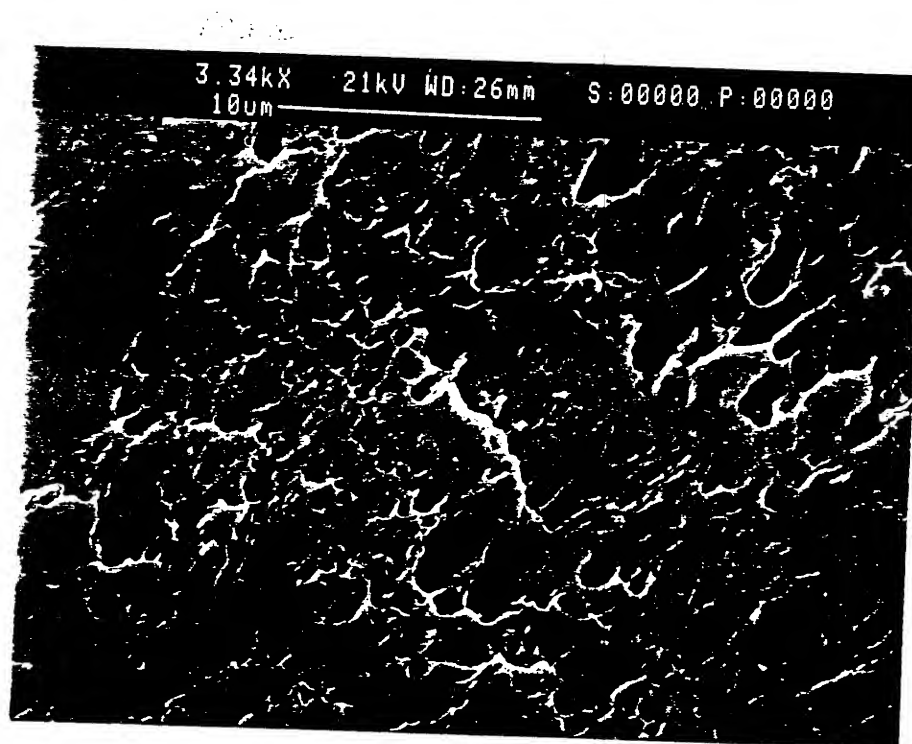
CONCLUSIONS: Based upon a metallurgical review of the failed rear upper control arm, the roll pin pieces appear to have failed due to ductile overstress.

Overstress Region

FIGURE 10: Top roll pin piece at
a magnification of up
to 3340X
